ODORS/WATER DAMAGE REASSESSMENT

**Massachusetts Rehabilitation Commission
340 Main Street
Worcester, Massachusetts**

Prepared by:
Massachusetts Department of Public Health
Bureau of Environmental Health
Indoor Air Quality Program
August 2019

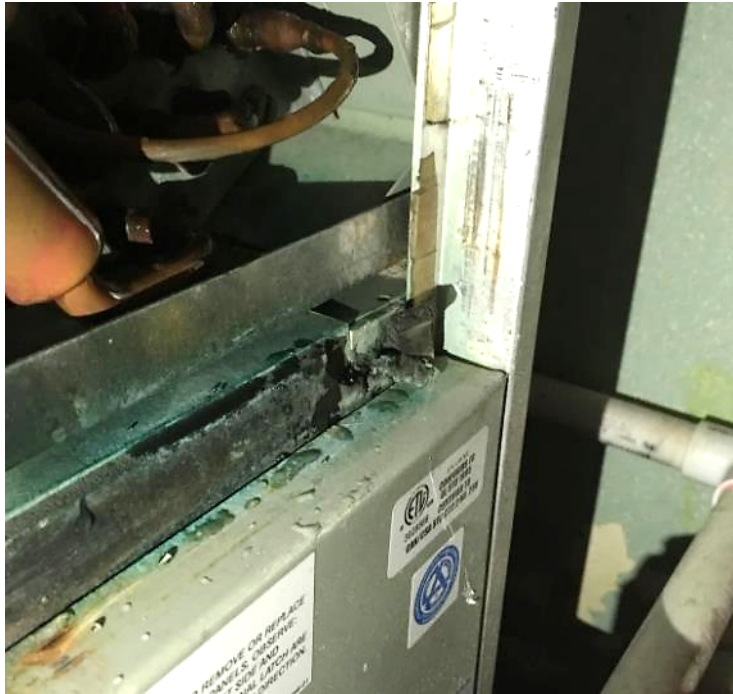
Picture 1

- The lower access panel of the AHU was ajar.
- Heavy corrosion and water droplets were observed outside the drip pan (Picture 1) indicating either a leak through the pan or water dripping on the outside from air passing through the coil assembly.
- The floor of the AHU cabinet was covered with a dust/oil film which can be mold growth media (Picture 2).
- A white, powder-like accumulation was found in the AHU below the drip pan. This material had a musty odor (Picture 3).
- The drip pan drain that empties into an open pipe in the adjacent restroom is connected to building's plumbing system (Picture 4).
- The AHU is located in a closet with a door with slats to allow air to be returned to the AHU. An examination for the restroom door found that air from the restroom is drawn by the AHU, which in turn, can draw air from the open drain in Picture 4.

Corrosion to AHU outside of drip pan

1. Have an HVAC company examine the interior of the AHU regarding the following issues:
 - a. the best methods of cleaning mold from the AHU drip pan and other surfaces;
 - b. repairing drainage of water into the drain pan;
 - c. repairing leaks from the drain pan;
 - d. improving condensation drainage;

- e. repairing pipe corrosion; and
 - f. repairing eroded insulation.
- 2. Given conditions, it is likely mold spores were captured and distributed by the fresh air supplies. Consideration should be given to cleaning ductwork connected to this AHU using methods outlined in “Introduction to HAVC System Cleaning Services” published by the National Air Duct Cleaners Association (NADCA, 2005).

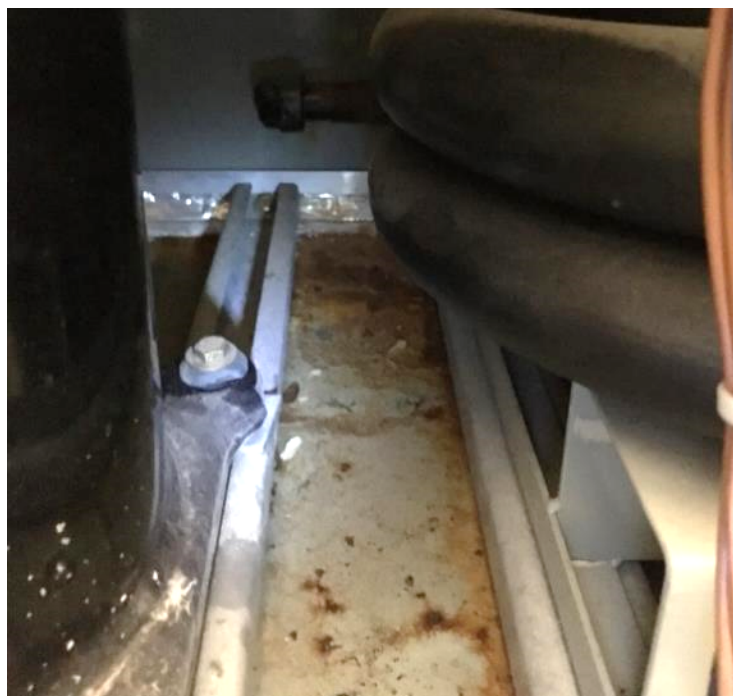
Picture 2

Oily film and debris inside AHU drip pan and cabinet

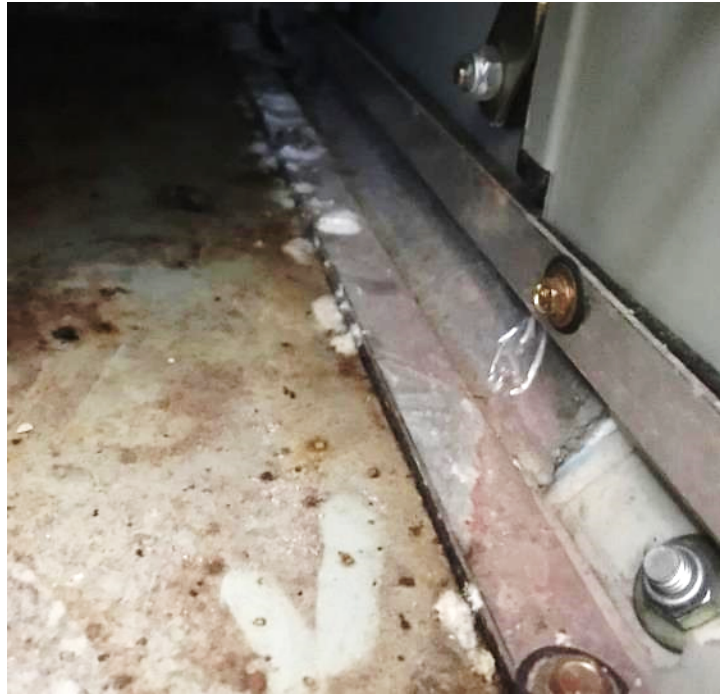
Picture 3

These conditions related to the AHU have contributed to the development of mold colonization within the AHU. The musty odor from the mold colonization can then be drawn into the airstream and distributed to hallways and offices served by this AHU via air diffusers. Additional distribution of the odors would occur due to flow of air back to the AHU return. The AHU may also be distributing odors from the nearby restroom as well as from the open pipe shown in Picture 4.

White spots on drip pan, likely to be mold colonies

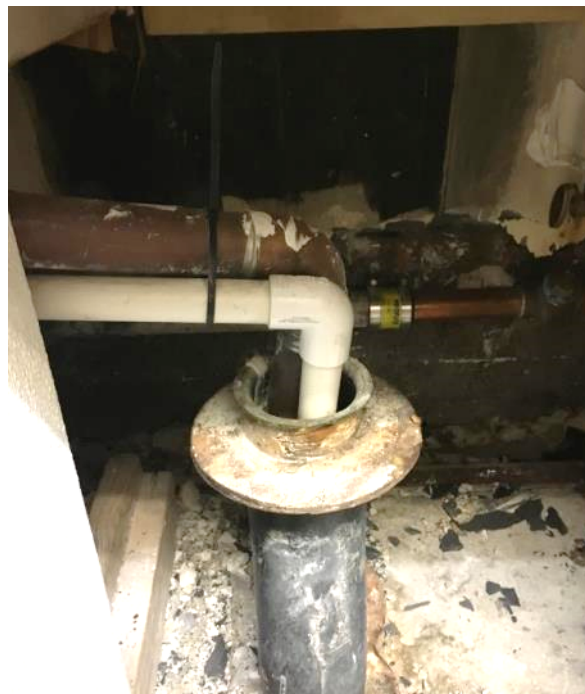
Picture 4

Open drain pipe in restroom with drain from condensation pan in it

- 3. Consideration should be given to replacing the condensation drain piped into the existing drain in the restroom (shown in Picture 4), with a condensation pump to reduce possible draw of air from this drain into the AHU. The drain opening should be plumbed in a manner to seal the drain system away from, contact with air.
